Manhole Inspection Summary

Manhole # S03AA2015MH

Insp Date: **8/10/06 10:46 AM**

Location Address: **6030 CROSS COUNTRY BLVD** Cross Street: **TANEY RD**

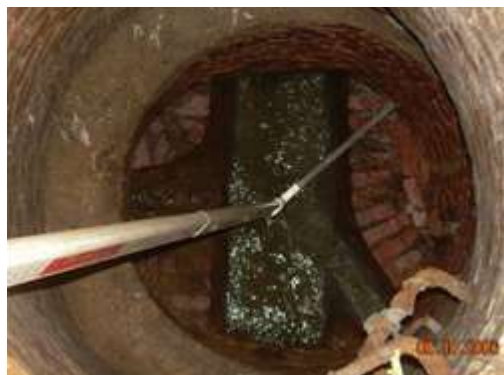
Top View

Corroded steps. Evidence of surcharge - Bench debris.

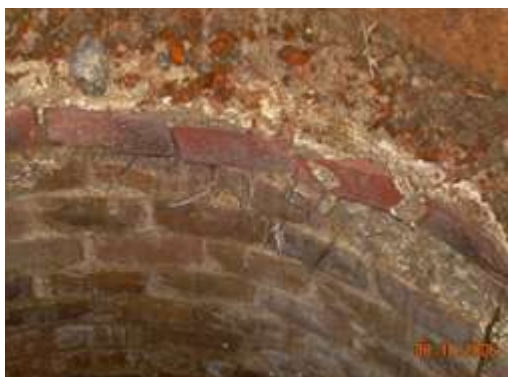
Defect

Frame offset. Adjustment deterioration, root intrusion and infiltration.

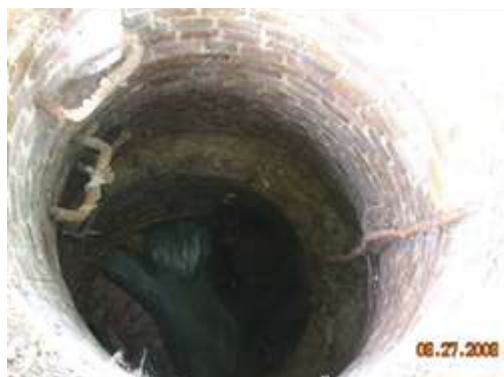
Defect

Adjustment infiltration. Corbel and Barrel root intrusion and infiltration.

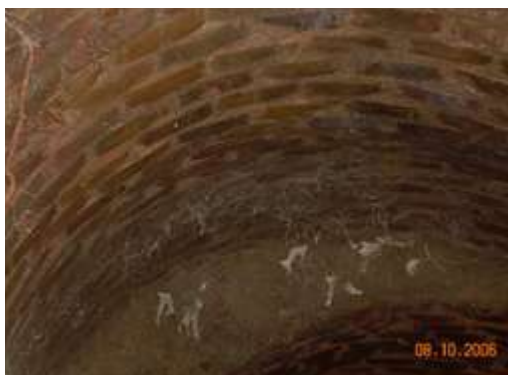
Defect

Adjustment and Corbel root intrusion and infiltration.

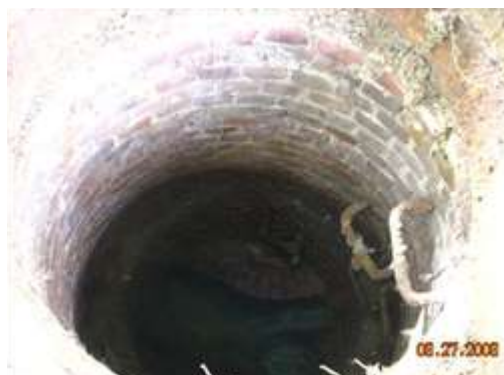
Defect

Adjustment, Corbel and Barrel root intrusion and infiltration - other side.

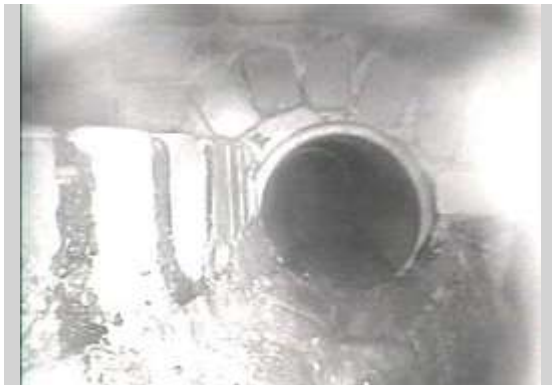
8 in. Circular Gravity Sewer Pipe In @ 5 O'Clock

Infiltration: **Evidence** Pipe Seal Cond: **Unknown**

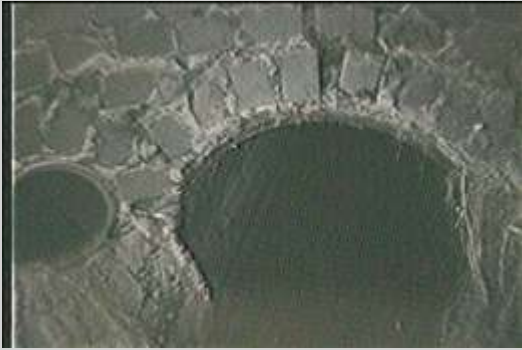
Pipe In @ 6 O'Clock

Barrel deterioration and infiltration. Channel deterioration.

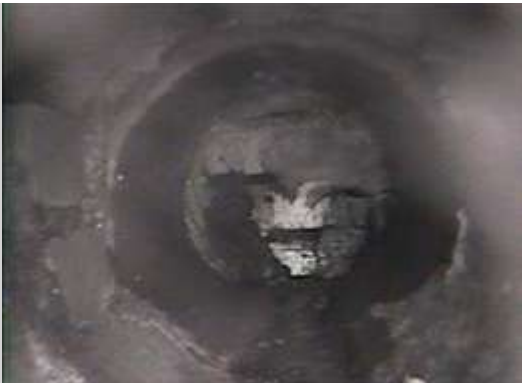
Pipe In @ 9 O'Clock

Capped.

Infiltration: **Evidence** Pipe Seal Cond: **Cracked**
